WADC TECHNICAL REPORT 55-56  
PART II

**PROTECTIVE SHOT PEENING OF PROPELLERS**

**Part II. Fatigue Tests**

*LESSELLS AND ASSOCIATES, INC.*

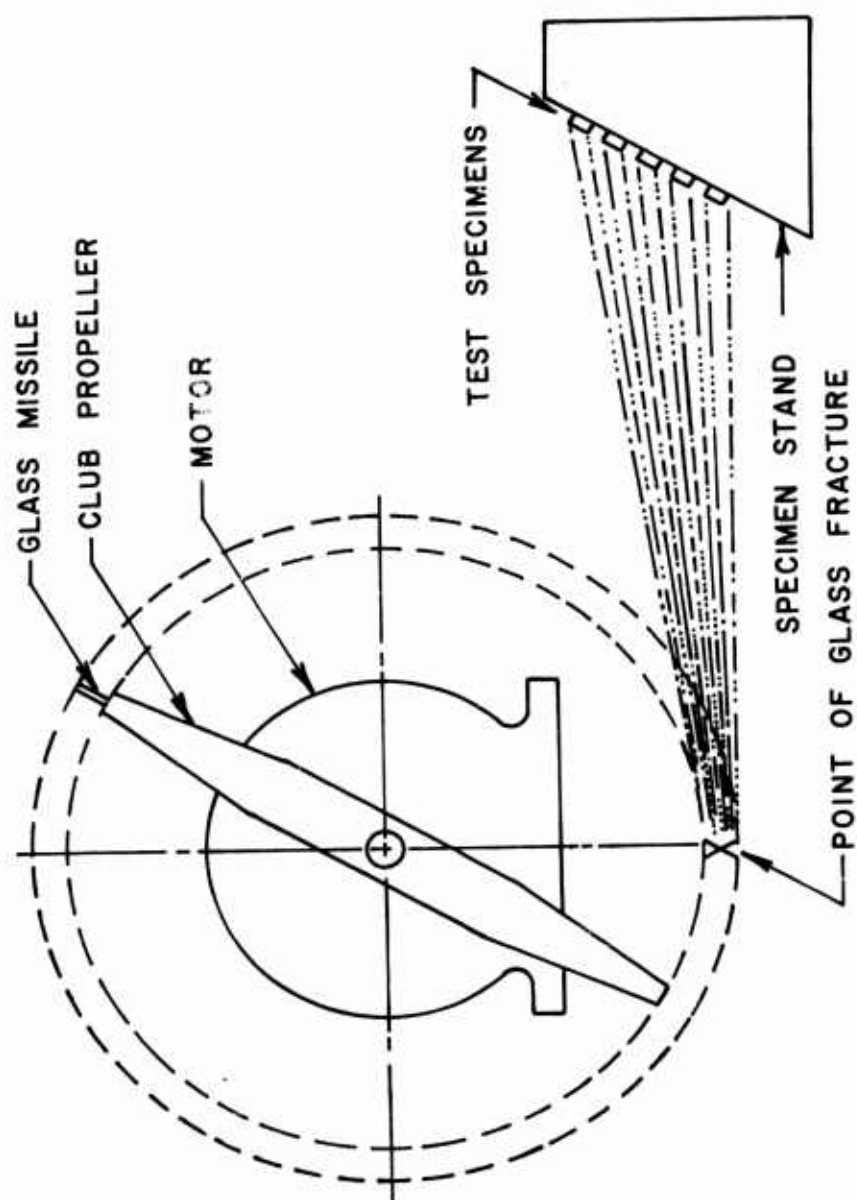
FIGURE 1. SCHEMATIC OF DAMAGING APPARATUS

Surface damage was introduced into the specimens (except those tested in the parent condition) in order to simulate service aircraft conditions. This process was performed on a special machine at the Propeller Laboratory, Wright Air Development Center. Figure 1 is a schematic of this device. A steel club propeller about 5 ft long and averaging about 3 in. wide is rotated by a large electric motor. Attached to one end of the club is a piece of glass about 3 in. by 1 in. by 1/4 in. With the motor running at speed, about 2400 rpm, a solenoid places an obstruction in the path of the glass. This causes pieces of broken glass to take up paths tangential to the arc of rotation where they strike fatigue test specimens on a nearby stand. Each specimen was subjected to 10 cycles of this treatment on either side. Tenspecimens were placed on the stand simultaneously, their relative positions being rotated between runs, such that the damage was identical insofar as possible.

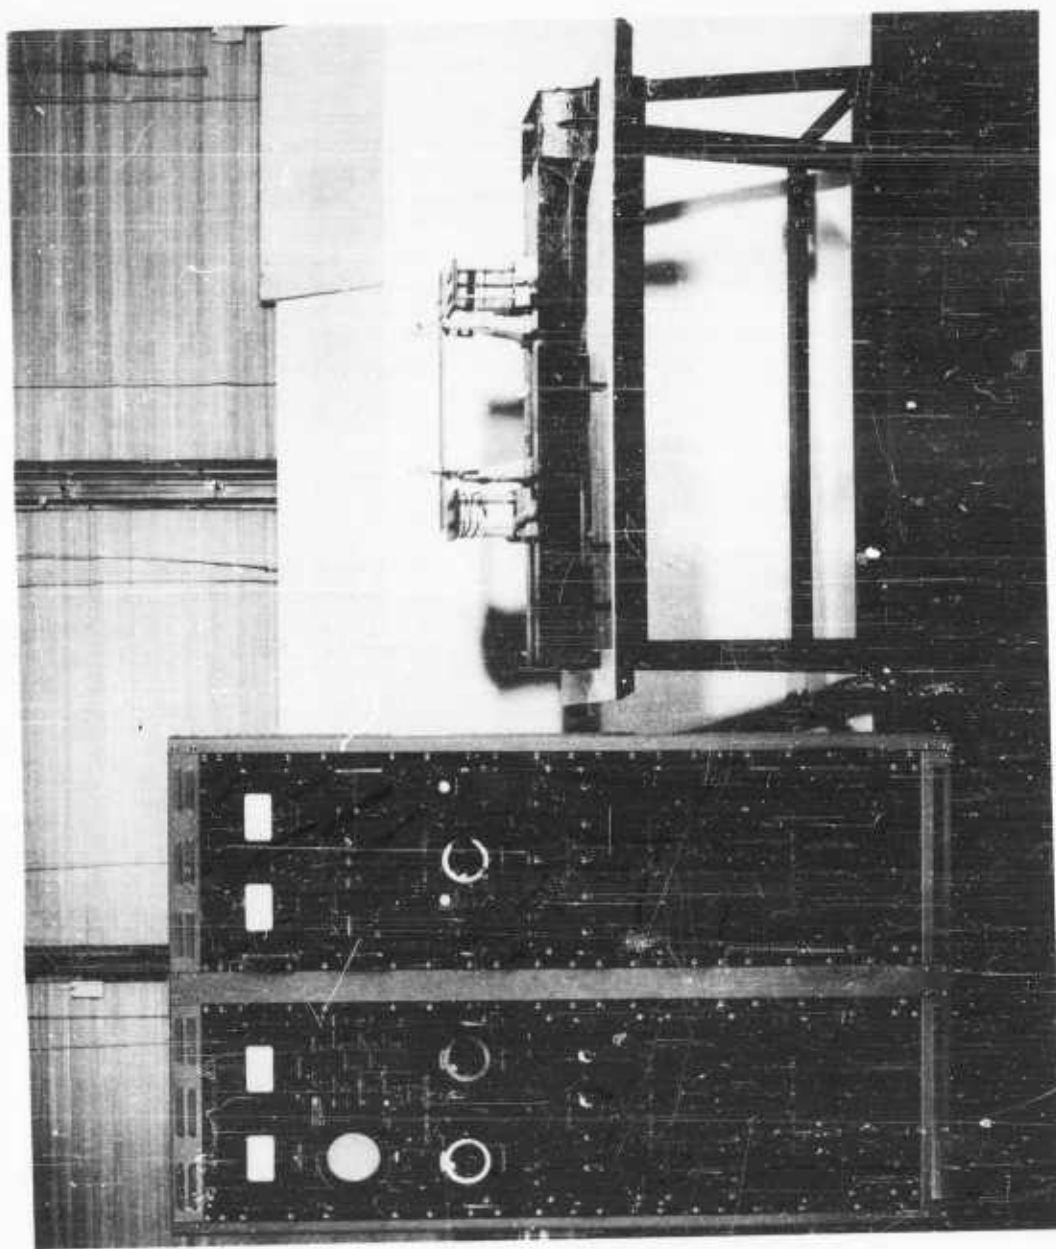
Figure 2 is a photograph of the fatigue machine. At the right a test specimen is shown in position for testing. It is supported at its nodal points. Electromagnets supplying the power for deflection are just below each end of the specimen. At the left in Figure 2 is the cabinet containing the excitation power supply and controls.

FIGURE 2. RESONANT BENDING FATIGUE MACHINE

The machine used for these tests was specially constructed to enable testing of the specimens by the Prot (4, 5) accelerated method. The specimens were magnetically excited in the fundamental free-free bending mode. For these bars this mode was at a frequency of about 230 cycles per second. Electronic controls were provided to maintain the required stress. In order to provide the control circuits with information of the stress level, a small accelerometer was attached near one end of the specimen. The accelerometer output was calibrated with respect to the optically-determined deflection

Controls of the machine could be set so as to provide a continuously increasing amplitude of vibration at any desired rate. Specimen failure was detected by reduction in natural frequency. This phenomenon was used to control the automatic shutoff. In this regard, it might be mentioned that the earliest indication of failure was an audible ring of about 6000 cycles per second. This was presumed to be a longitudinal acoustical wave excited in the bar by the impact of the sides of a crack against each other.

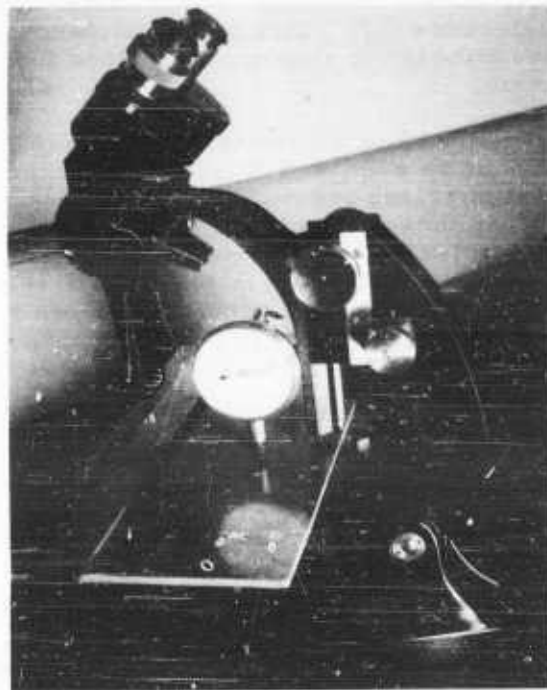
Figure 3. Apparatus for Gouge Depth Measurement

After testing, the failures were examined. In the cases where failure originated at a simulated gouge, the gouge depth was measured optically by means of a microscope with a dial gage mounted between the barrel and the stage. This arrangement is shown in Figure 3. In the case of shallow gouges a metallurgical microscope with a 6 mm objective and micrometer screw was used for increased accuracy. Accuracy of gouge depth measurement decreased with increasing peening intensity because of the rough surface. It was impossible to observe gouges on many of the heavily peened specimens, much less measure their depths. Photographs of the cracks were taken in many cases. Where necessary, specimens were bent to a small permanent set in order to delineate the cracks.

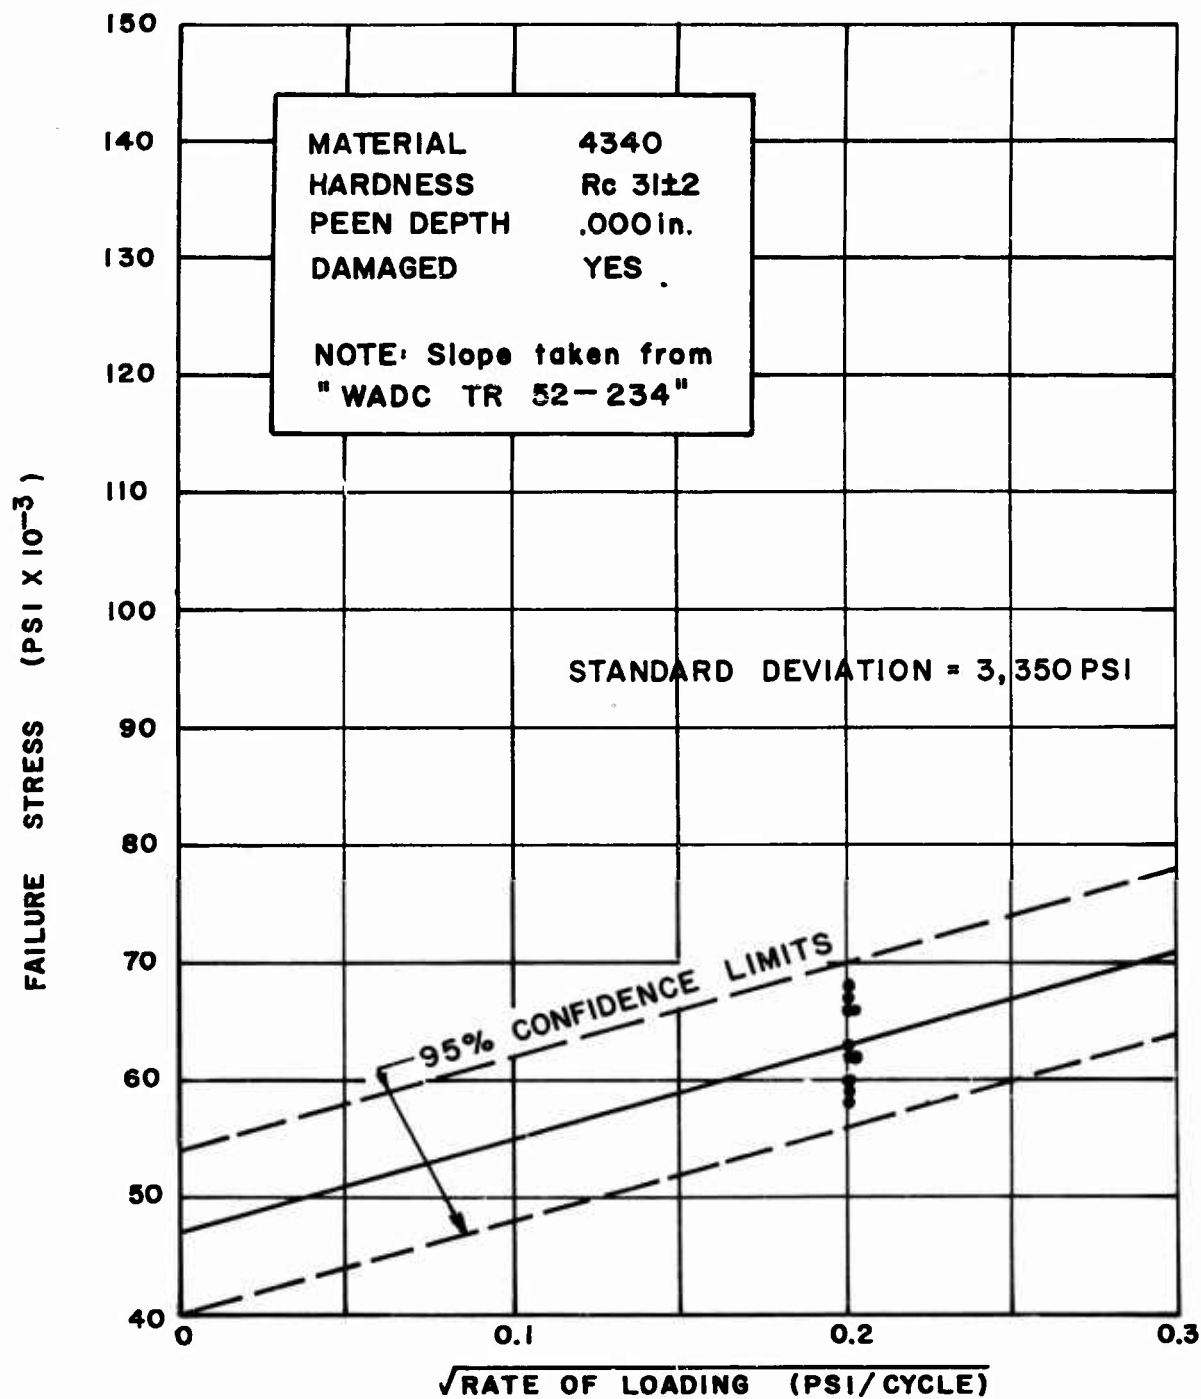
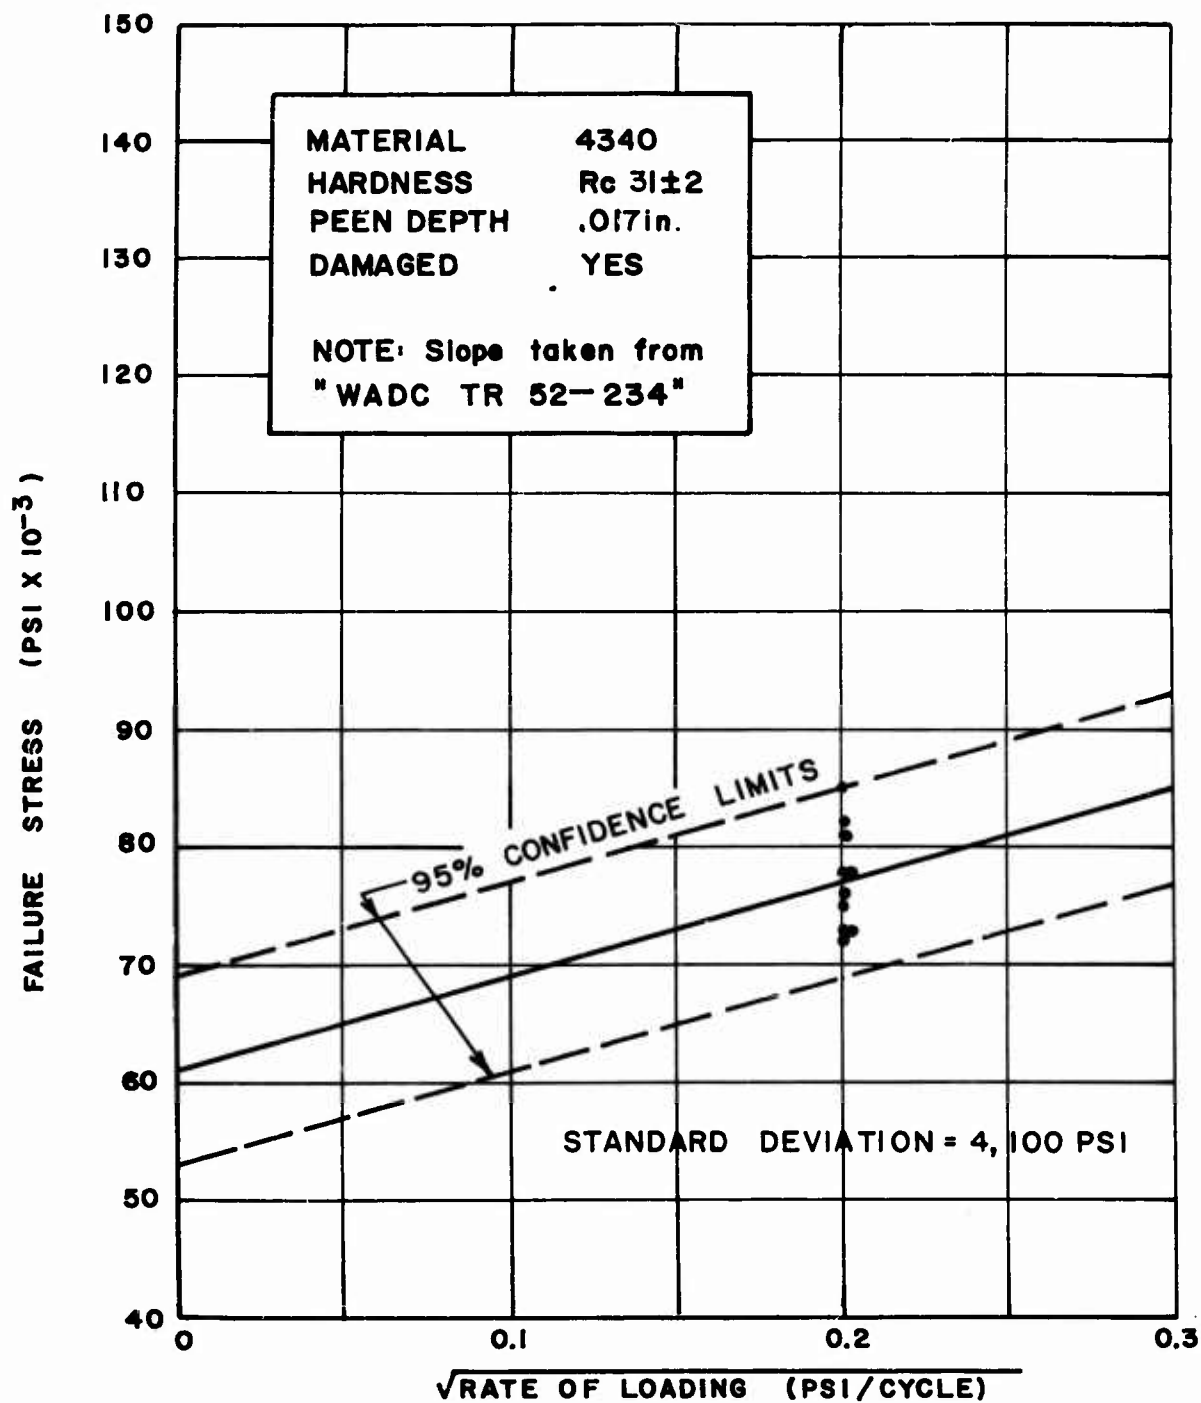
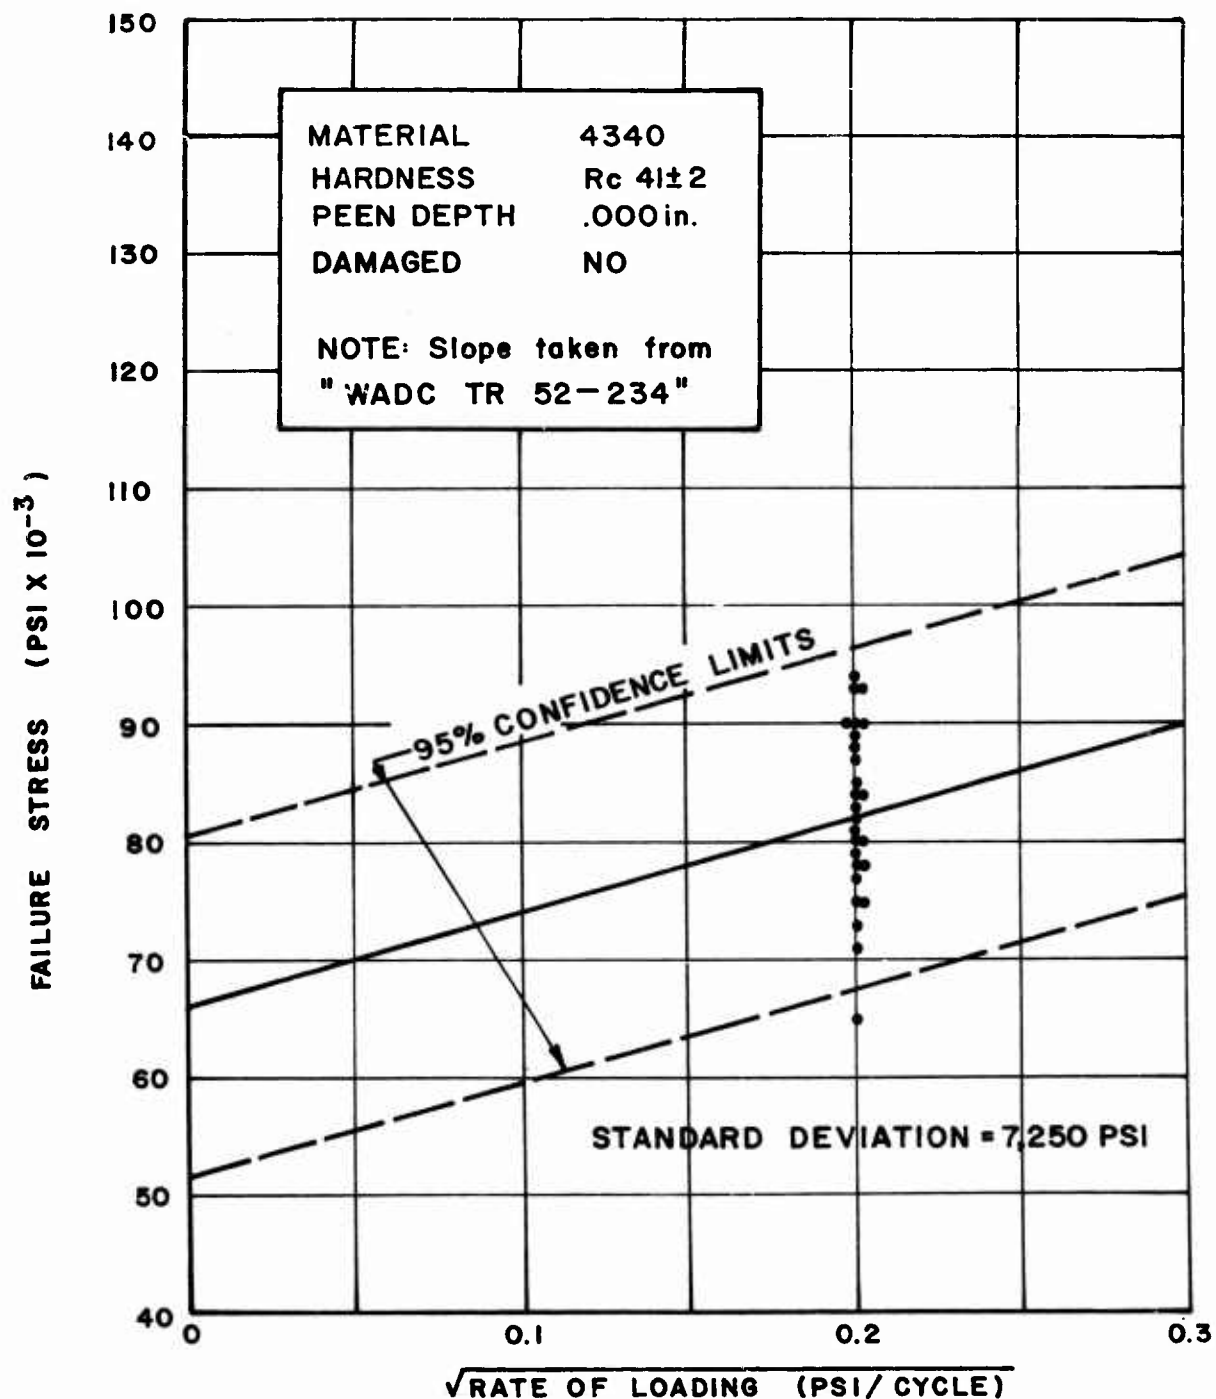
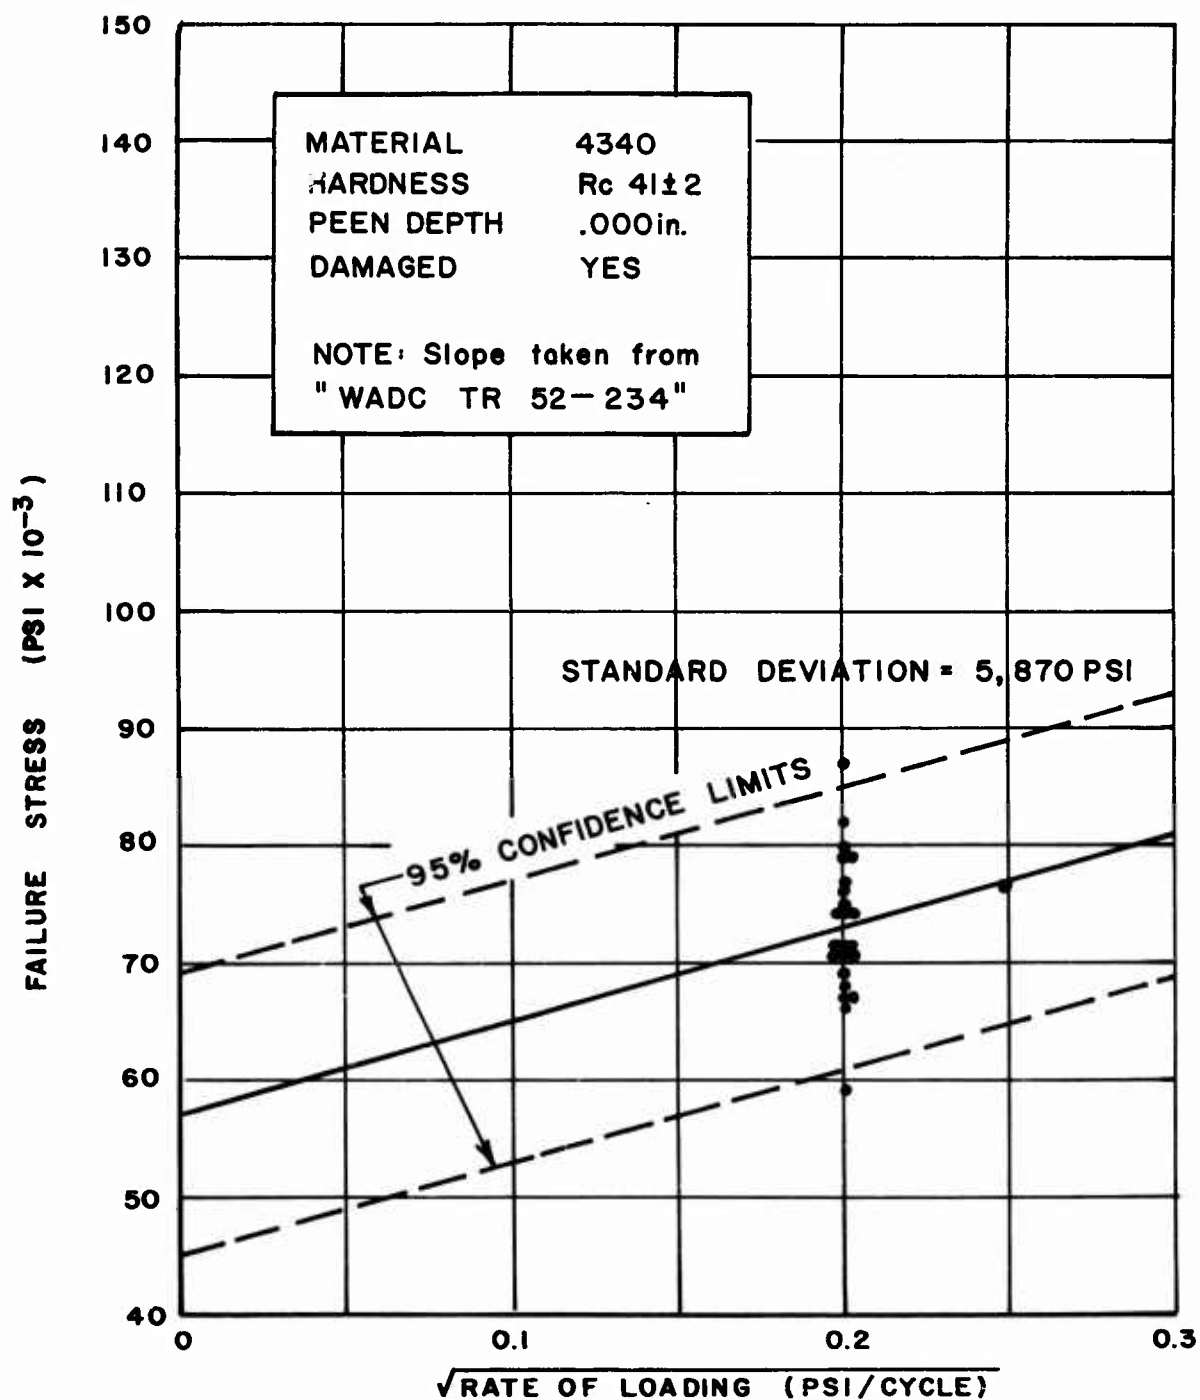
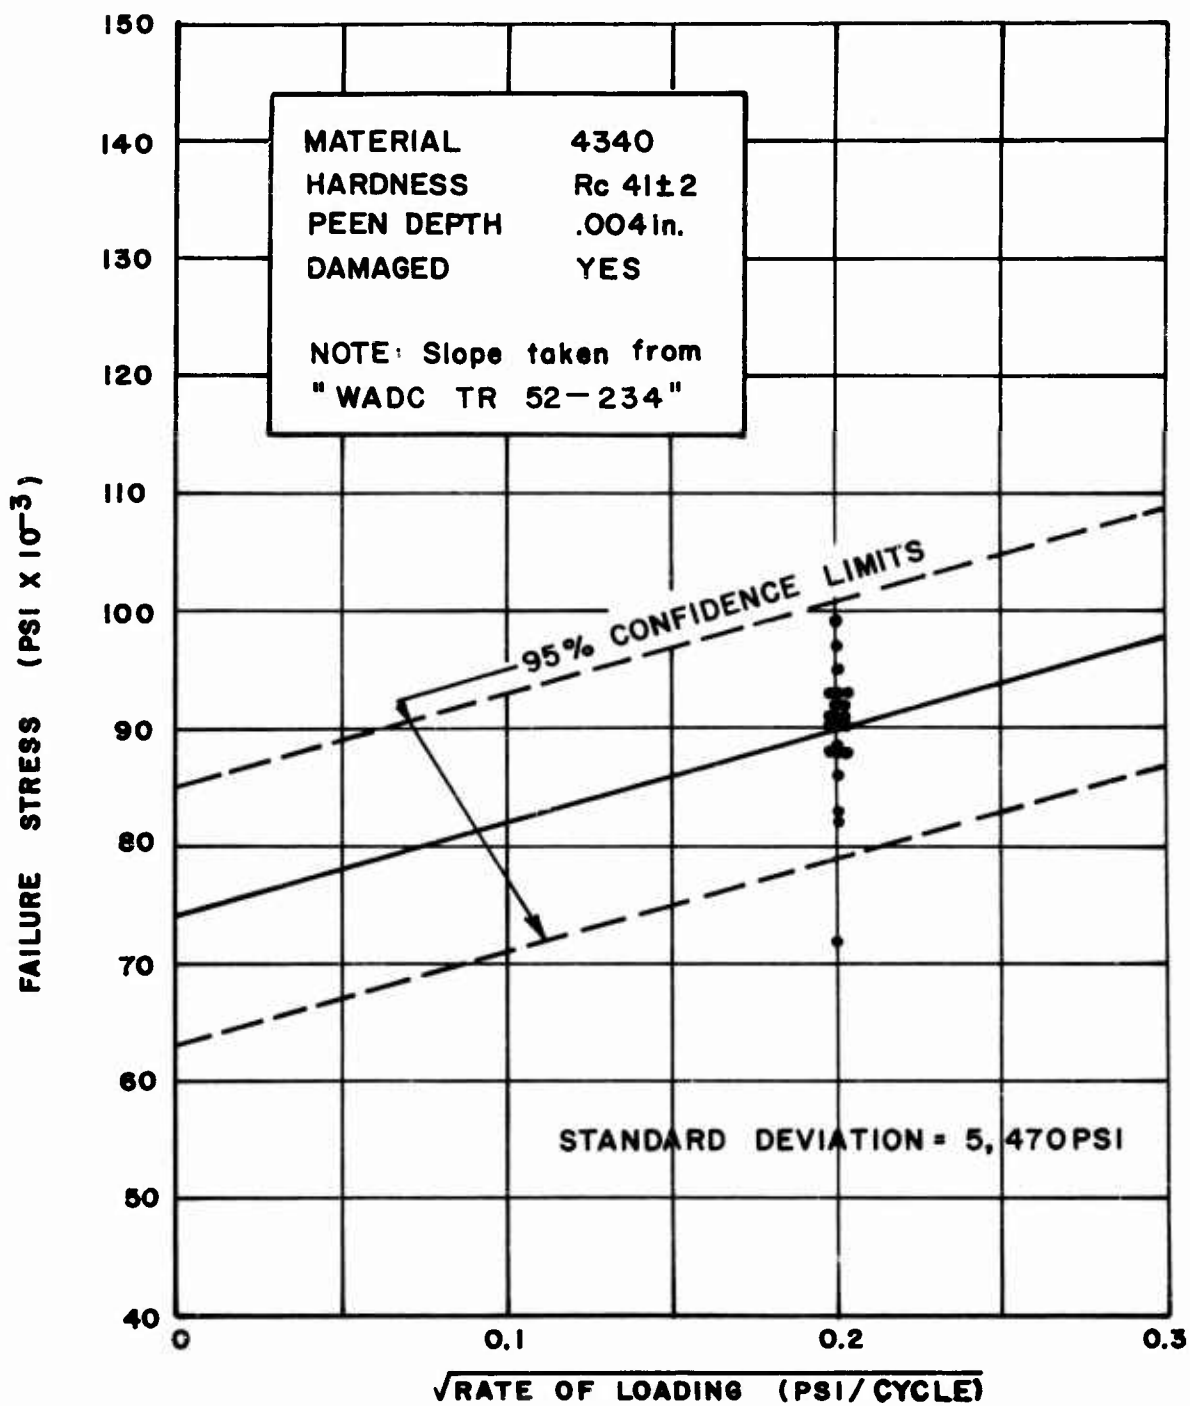
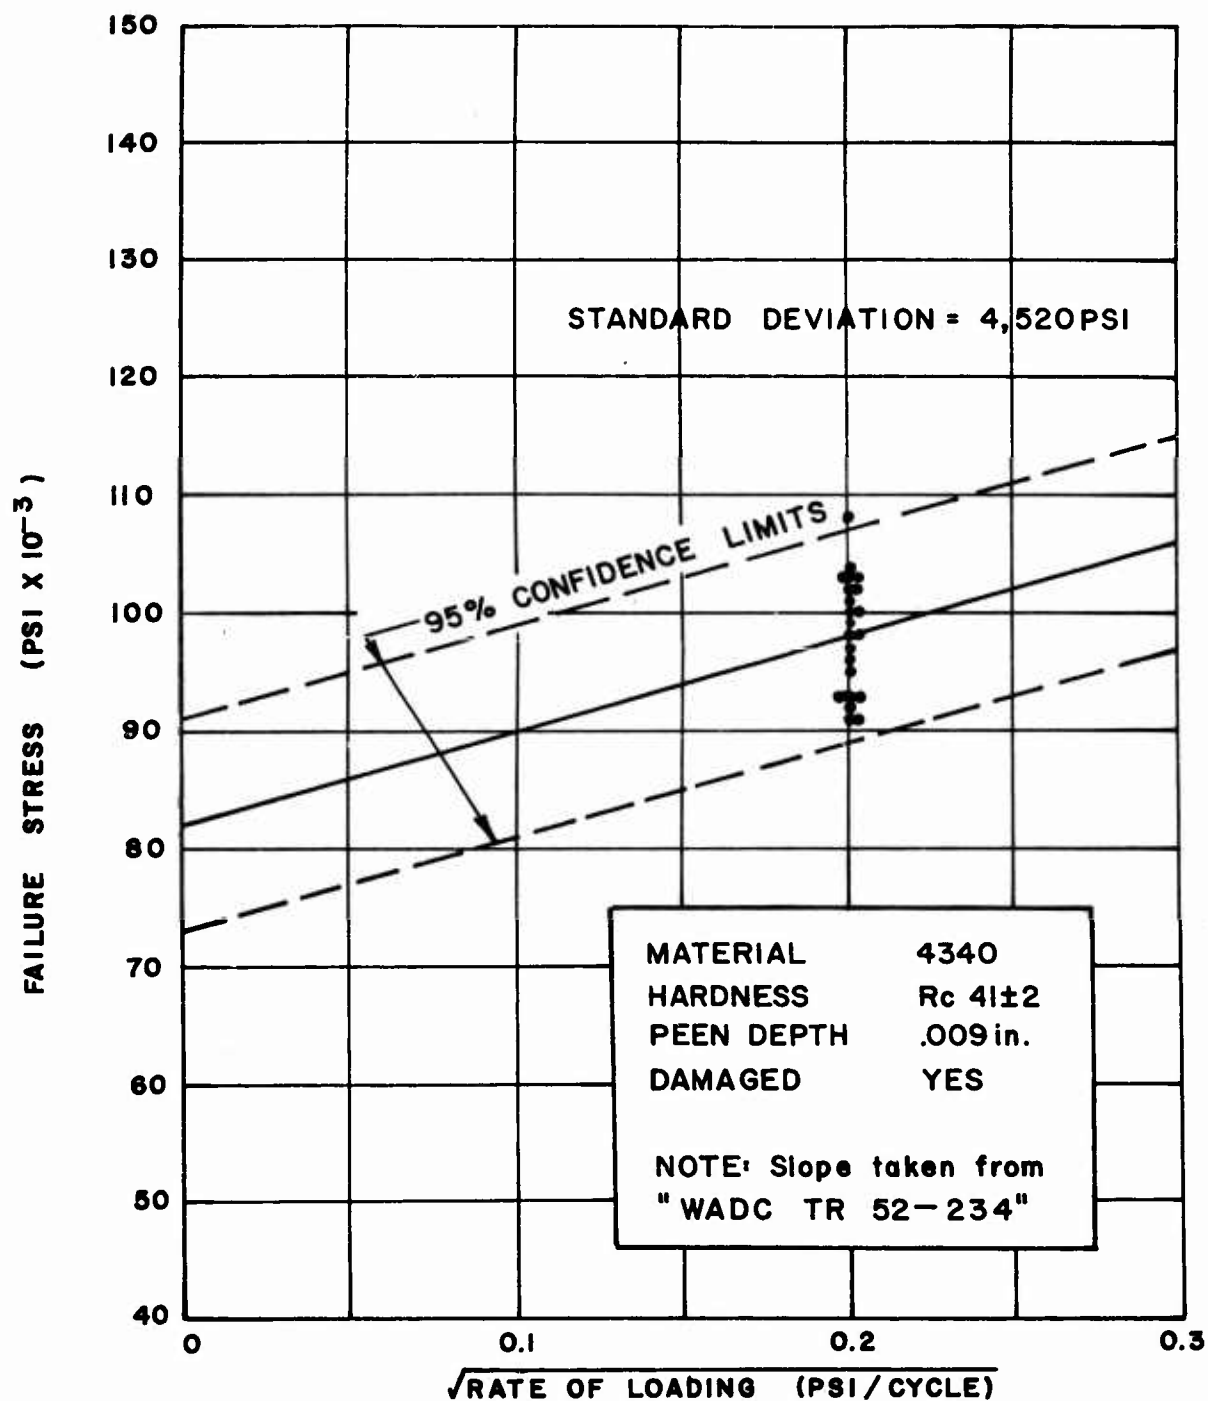
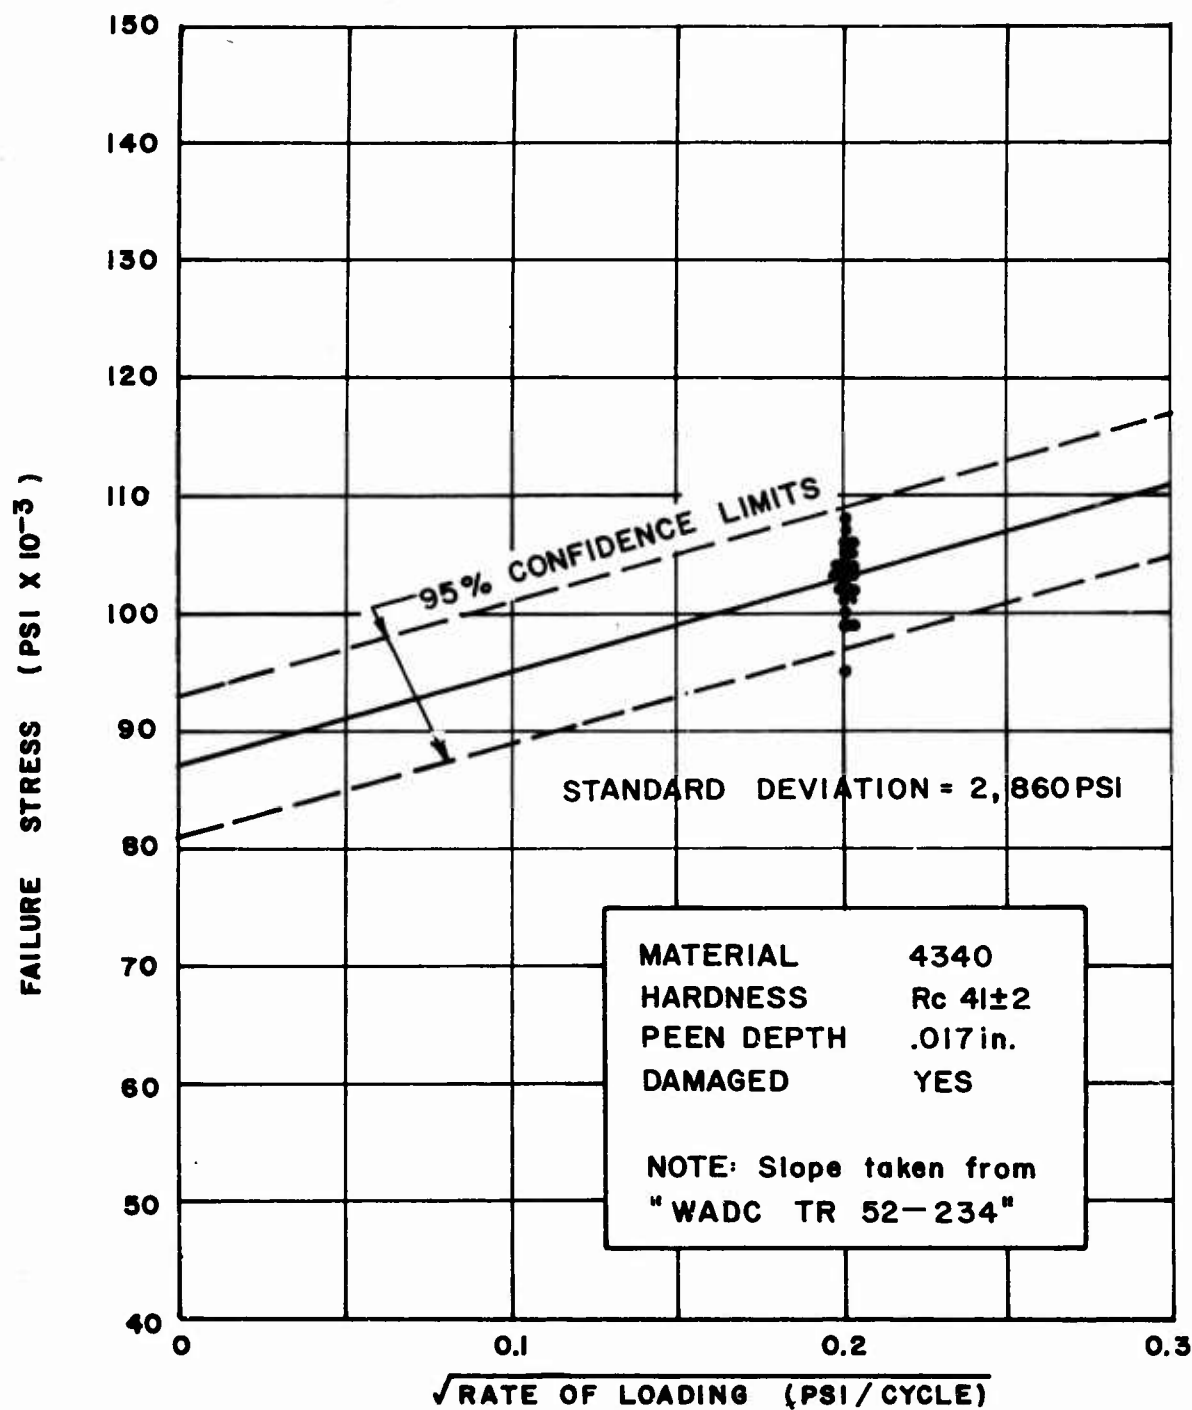
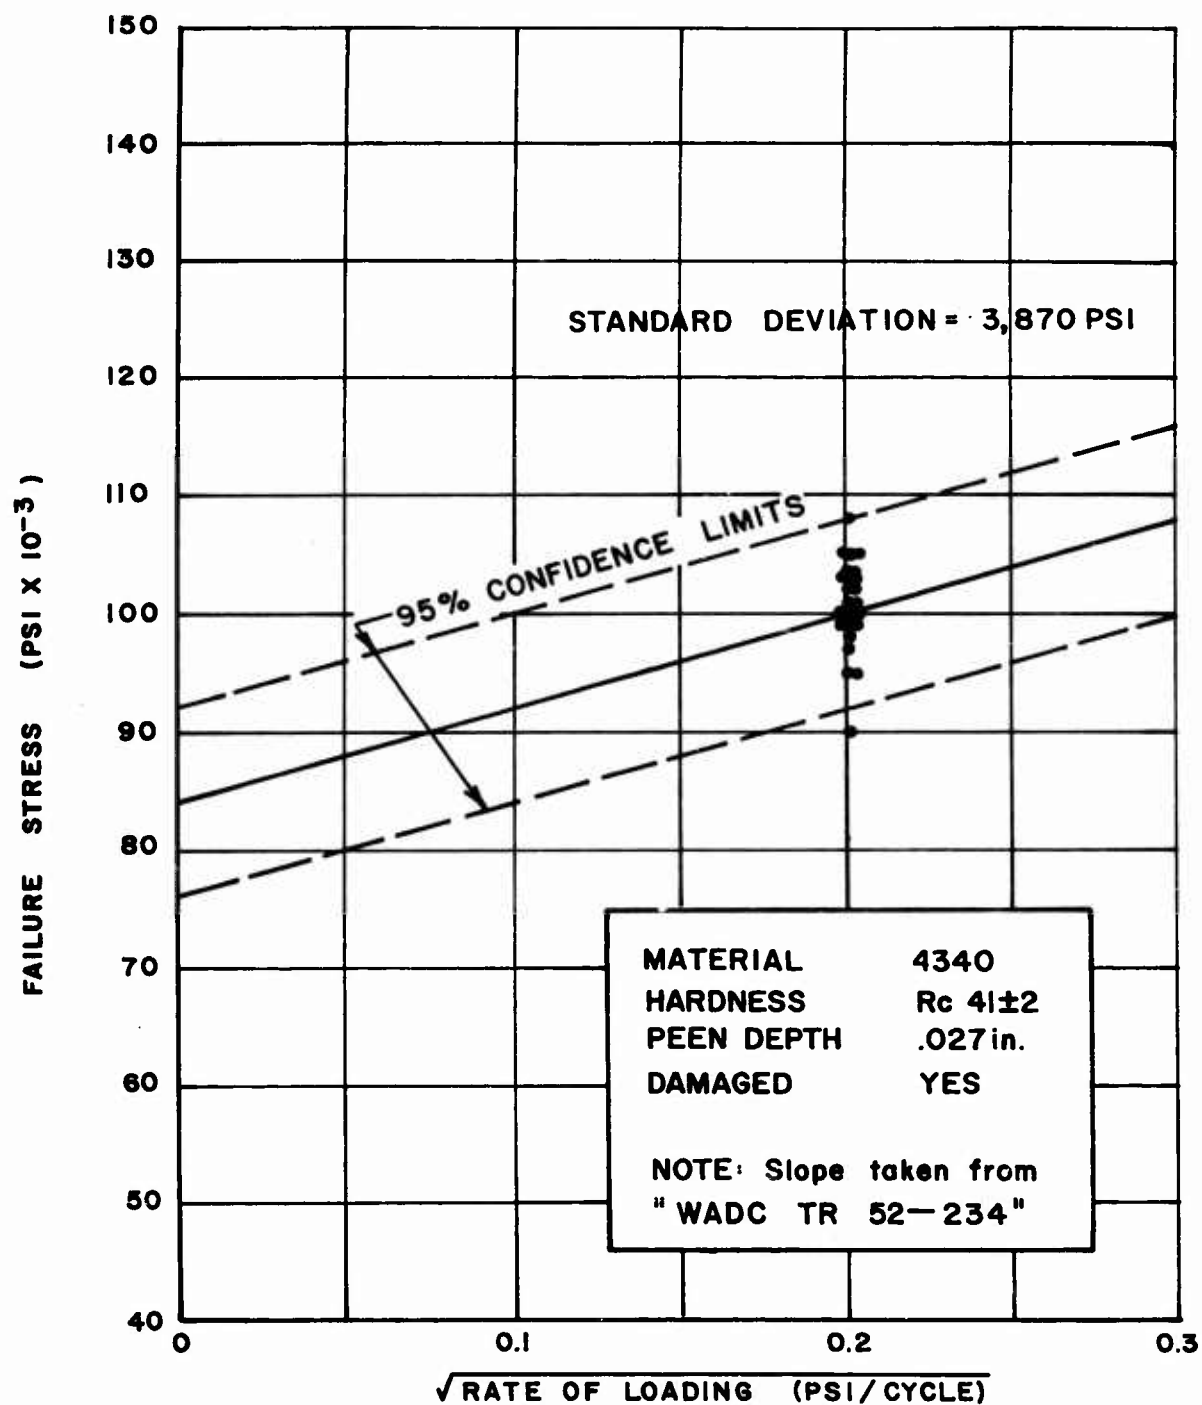
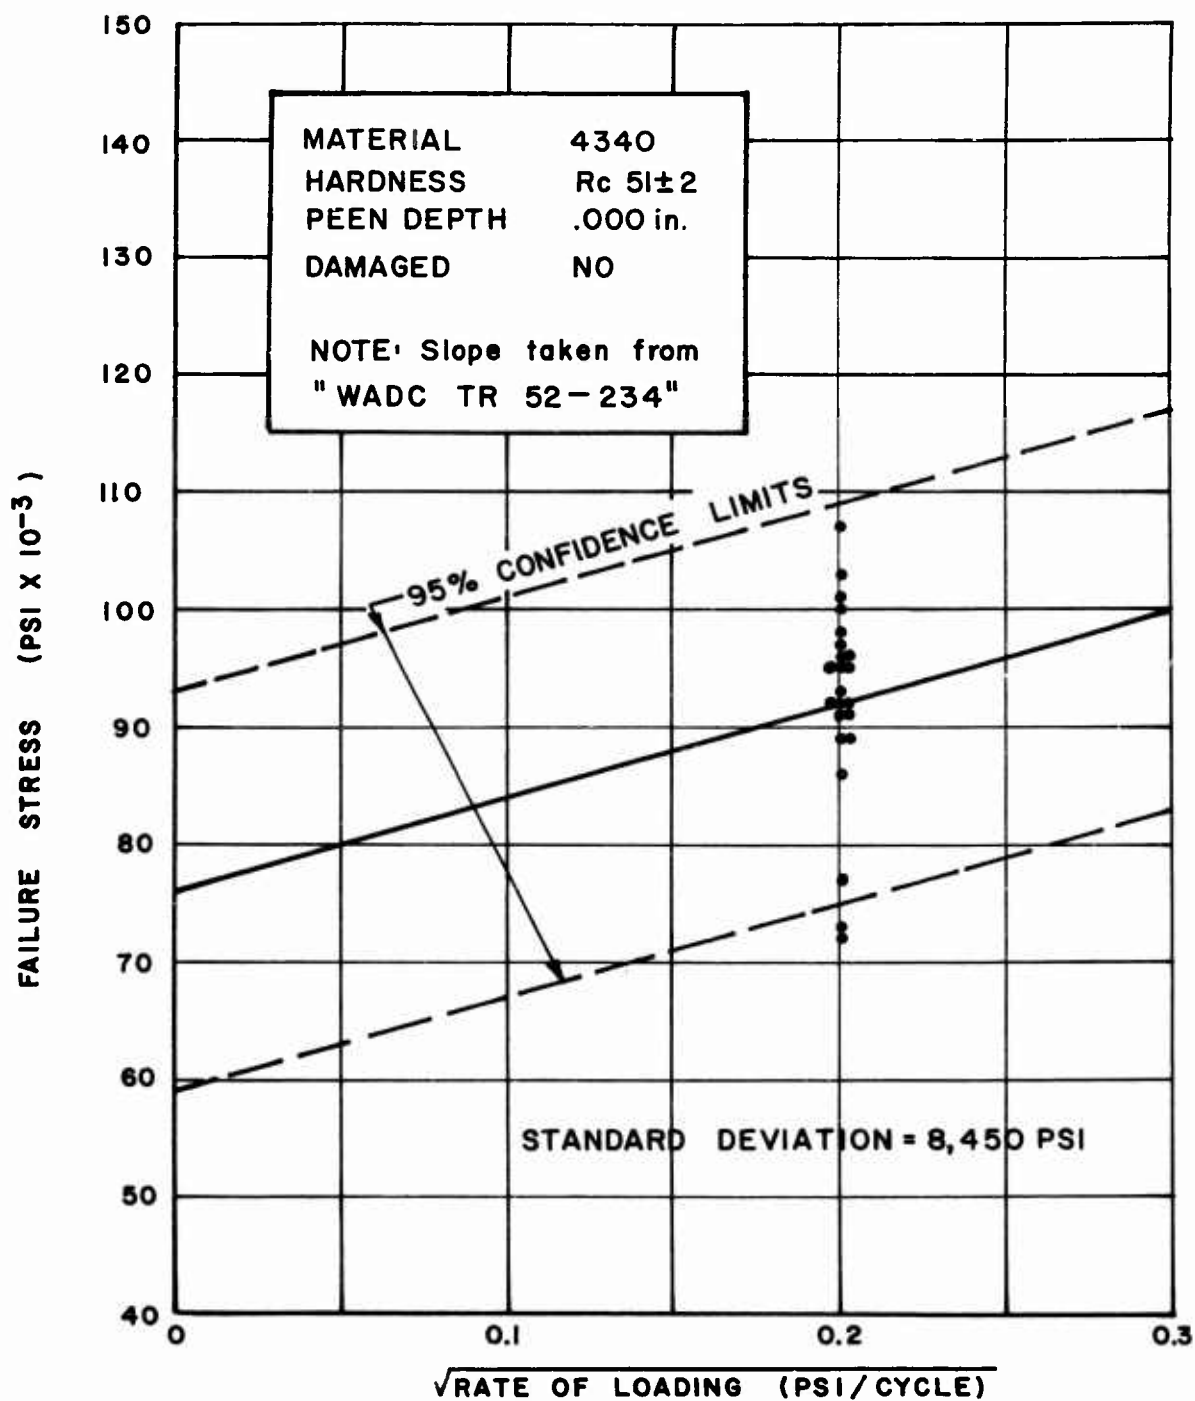
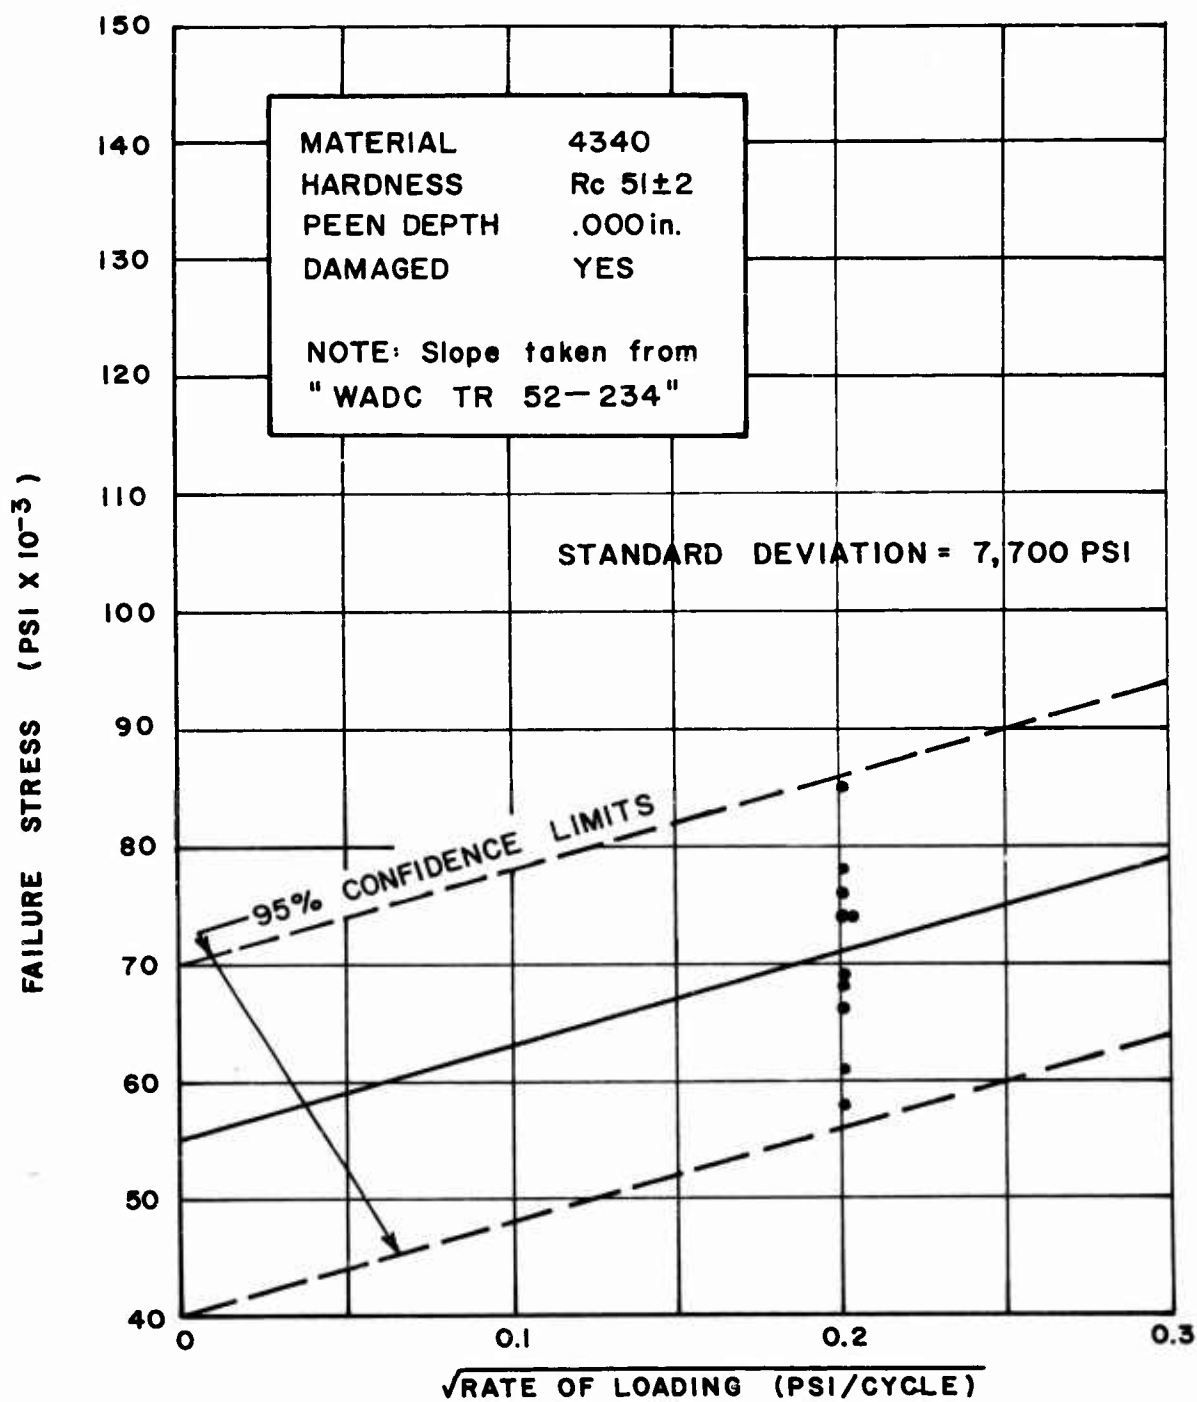
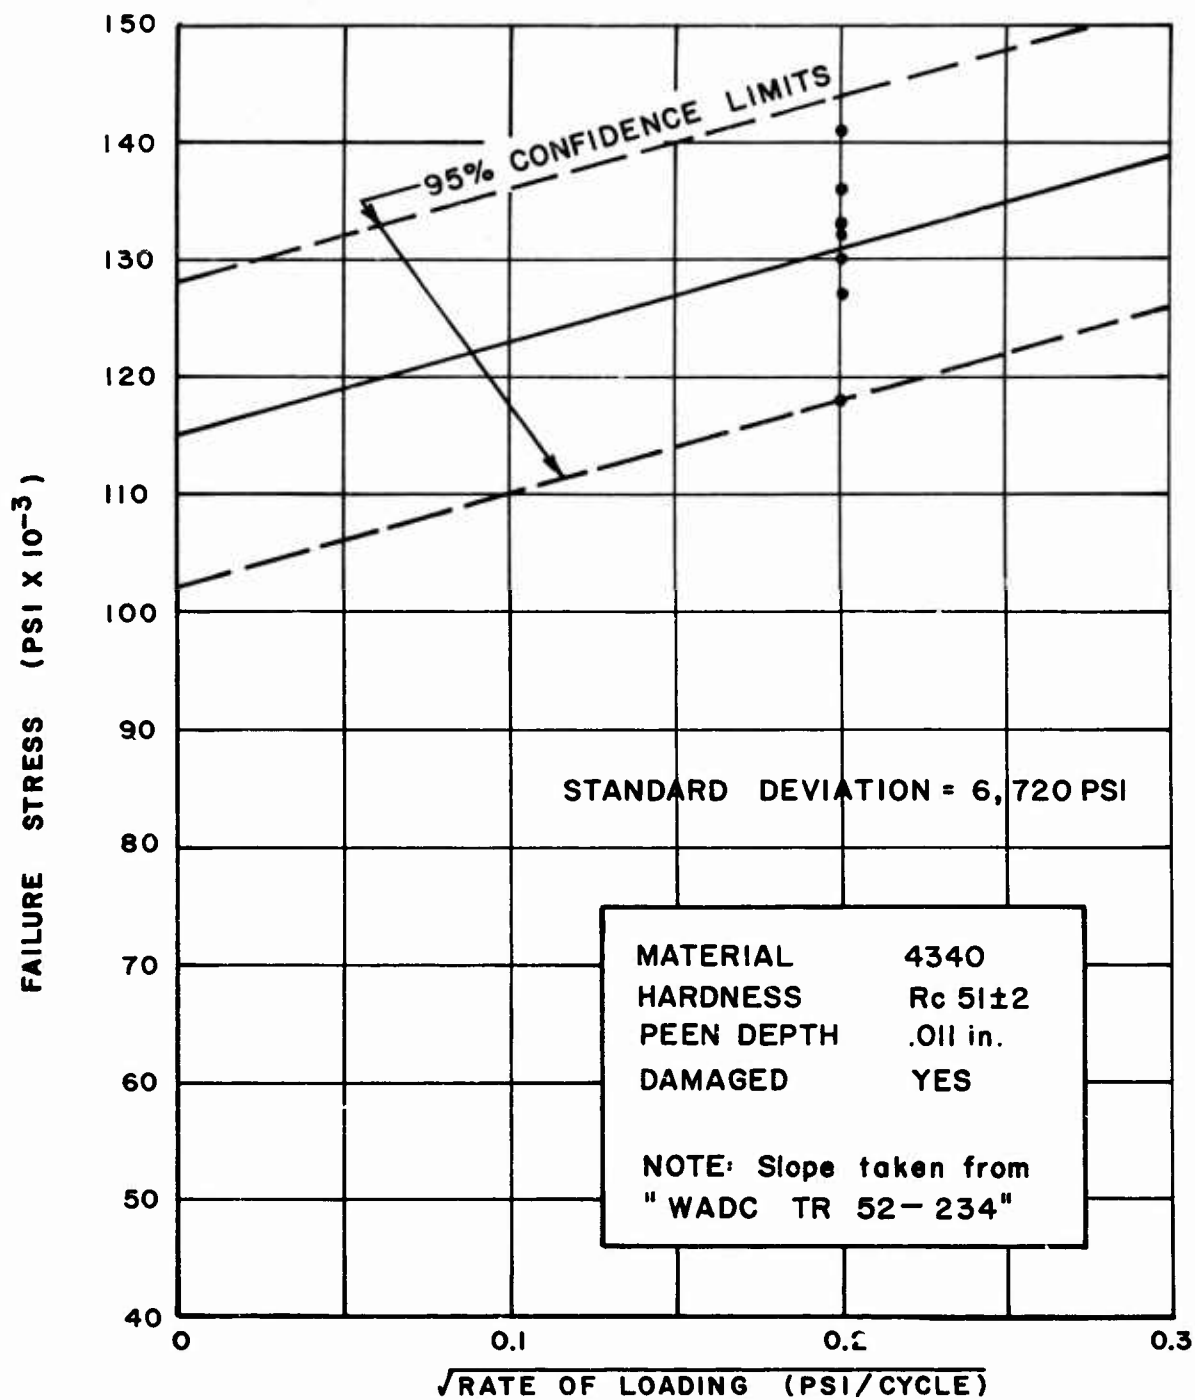
Failure stresses of all specimens are given in Table 3. Individual test points for each group of specimens are plotted in Figures 4 through 14. Endurance limits are obtained by extrapolation to zero rate of stress increase.

As noted, the slope of the extrapolation is assumed to be that reported in Reference (6). The 95% confidence limits are extrapolated at the same slope, although it should be realized that they may be in error near the zero ordinate.
